# Summary of measurements on FEAST2 modules to understand the failures observed in the CMS pixel system

F. Faccio, S. Michelis, G. Ripamonti  
CERN EP-ESE-ME

October 15, 2018

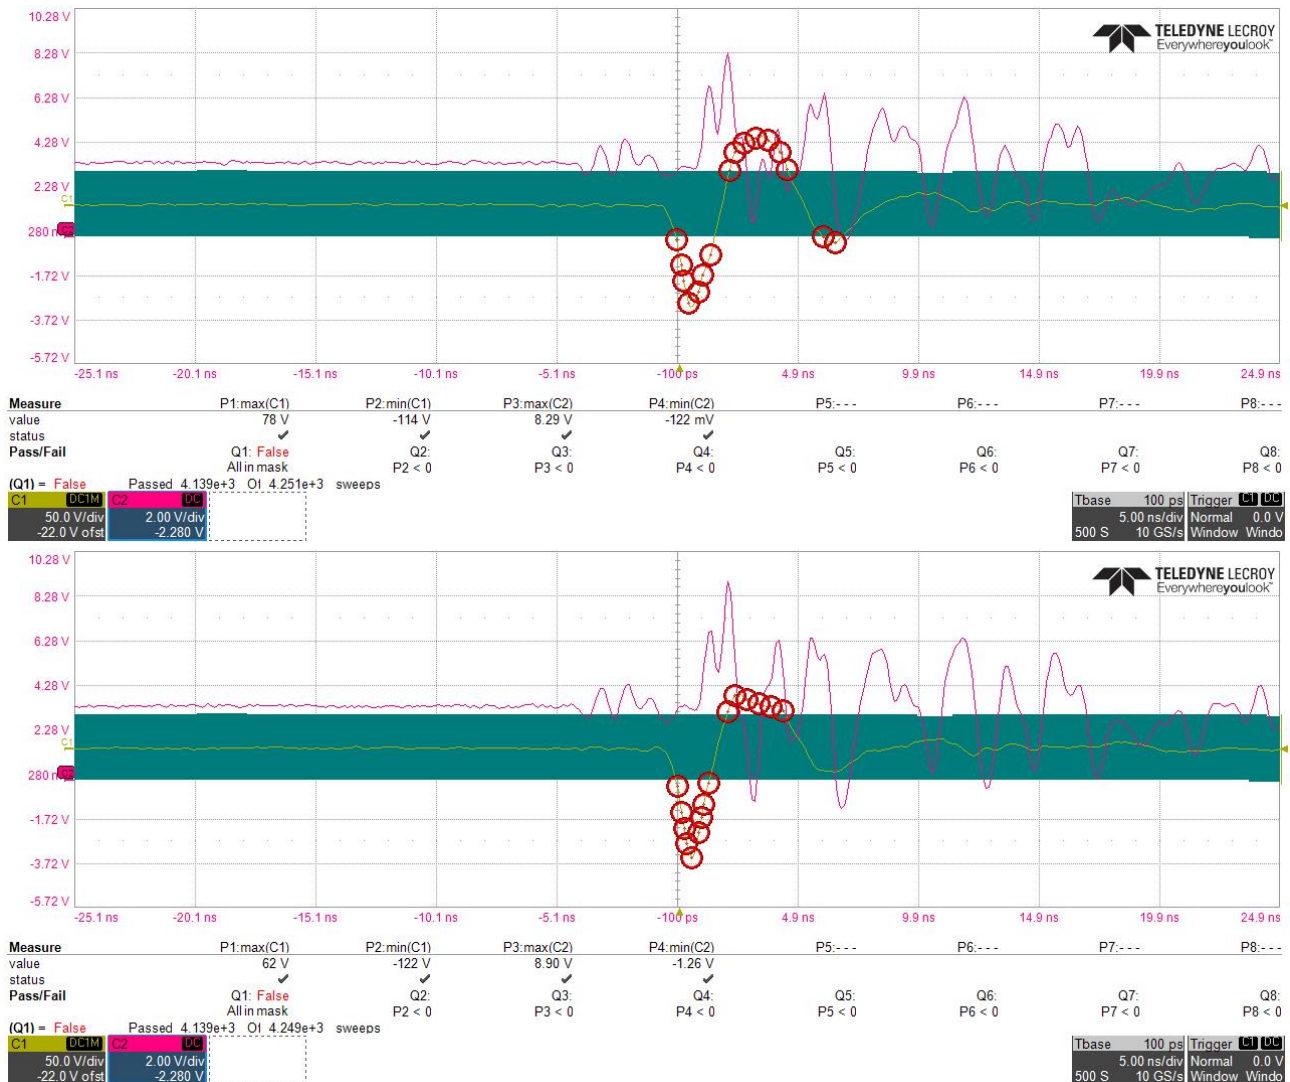
Some waveforms taken with the oscilloscope on the Enable and V33Dr nodes during the discharge (on the enable) are illustrated in Fig.4.

Figure 4: Screenshots of the oscilloscope used to observe the Enable and V33Dr nodes during ESD discharge tests. The yellow trace (with red dots) is the enable, the purple is V33Dr. The negative peak of the enable is 114V in the top and 122 V in the bottom image. V33Dr can raise to almost 9V (bottom image), making a damage on that node plausible.

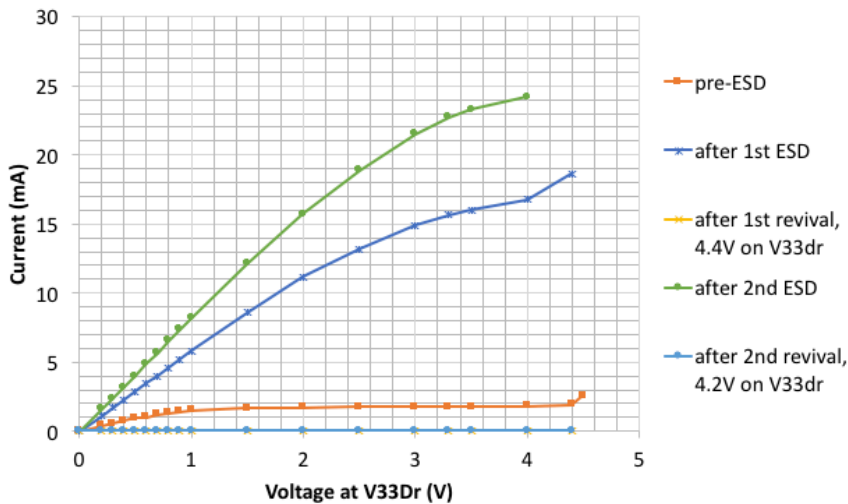
Figure 5: Result of the measurement of the output characteristics of the clamp NMOS transistors in a sample damaged in the High Current mode with ESD discharges. The yellow curve, (after 1st revival) is perfectly superposed to the orange (pre-ESD).

In the samples damaged with the ESD discharge, the result clearly indicates that damage occurs in the clamp NMOS transistors. After the first discharge, the left clamp in Fig.2 is broken and presents an ohmic path to ground. A successful "revival" operation breaks this path, and as a result no current can be measured anymore in the  $I_{ds}=f(V_{ds})$  curve (the other transistor is turned off in the measurement's conditions). If a second ESD discharges leads to a High Current state again, then we can observe once more a linear current behaviour indicating that the second clamp (right transistor) has been damaged. A second successful "revival" breaks this second path - but now there is no clamp transistor anymore, hence the sample can not be damaged by other discharges. In the samples damaged in CMS, instead, it looks like the additional "high" current flows in a diode - below about 0.7V the curve follows the pre-damage characteristics. Successive "revivals" gradually increase the resistance of the additional path (orange line in Fig.6), then fully break it (yellow line) and the output characteristics of the NMOS clamp is again as in fresh samples - so this device has never been damaged. As stated above, this indicates that the High Current damage mechanism is different in the two cases.

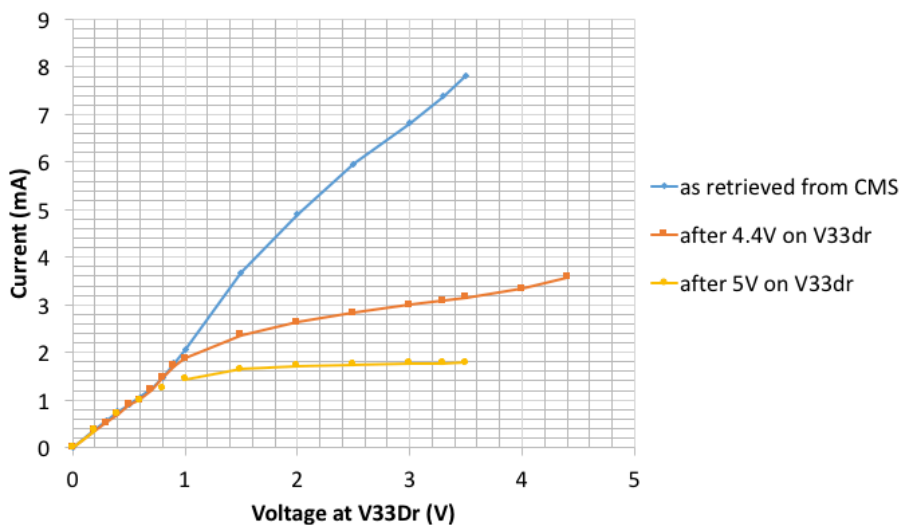
Figure 6: Result of the measurement of the output characteristics of the clamp NMOS transistors in a sample damaged in the High Current mode in CMS.

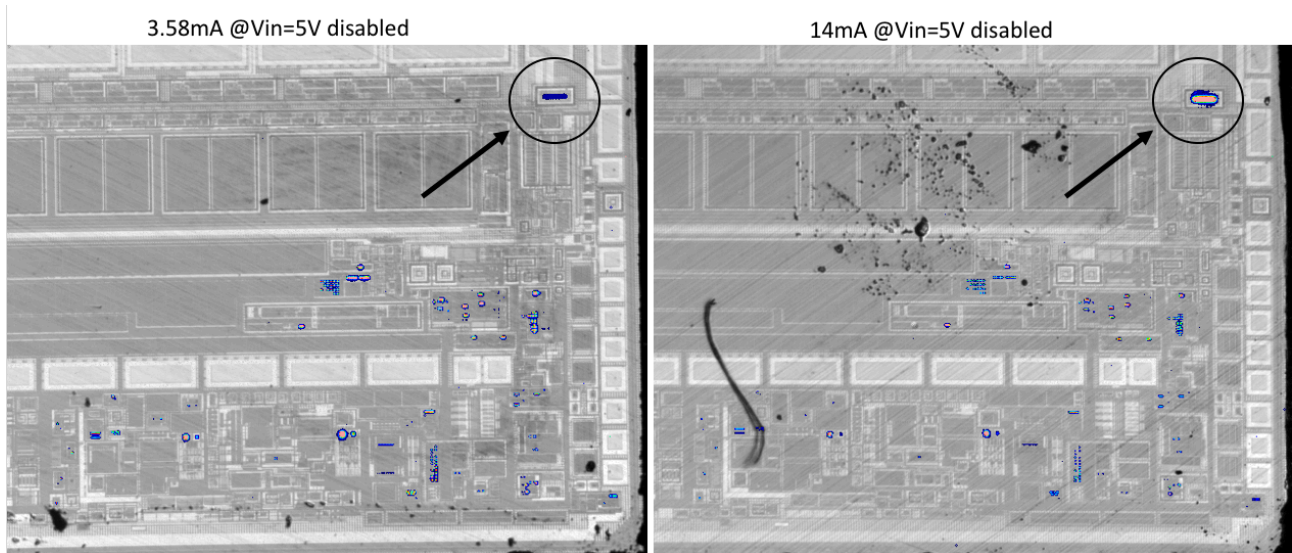
High Current (HC) sample has a considerably larger consumption: 14mA versus 3.58 in the fresh device.

Figure 7: Emission scan images for a fresh (left) and a High Current sample from CMS (right). The coloured areas indicate locations with relatively large current flow. To the top right, the bootstrap diode drives much more current in the damaged sample: the orange colour stands for a larger current density.

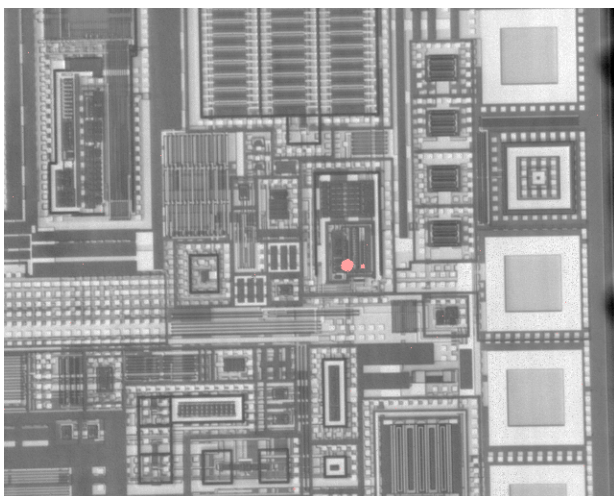
The same Failure Analysis was also carried on Broken samples at Maser. In these samples the current appears to be flowing in the clamp NMOS transistors as well as in an inverter that is connected to them. An example image is shown in Fig.8, where the red dot represents a current flowing in one of the clamp NMOS transistors.

Figure 8: Emission scan image for a Broken sample from CMS: the red dot indicates that a relatively large current flows in one of the two clamp transistors.

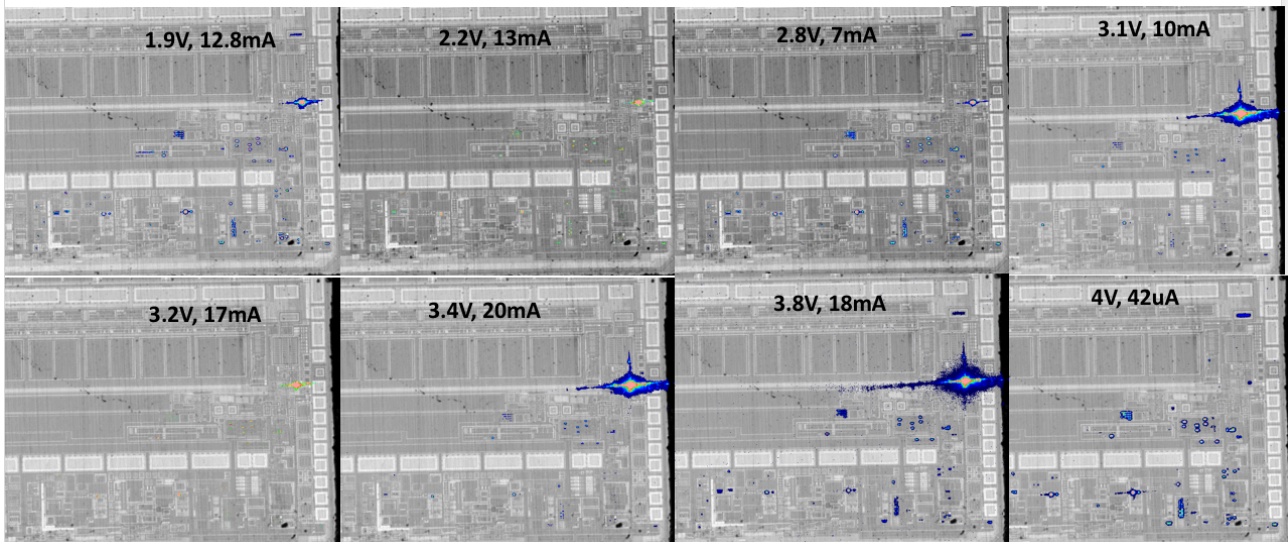
Figure 9: Sequence of emission scan images taken while increasing the voltage applied to V33Dr on a Broken sample (“revival” procedure, in this case with a resistance in series to limit the current). After a current of about 20mA is reached for some time, the parasitic current path is broken and the converter is back to functionality.

This evidence confirms the initial suspicion that the damage of one of the clamp transistors is responsible for the failure of the converters in CMS: when the transistor is damaged, the voltage at either the UVLO\_regs or Vdd\_OK in Fig.2 rises, which prevents the correct functionality of the PMOS pass transistor. As a consequence, the V33Dr regulator does not work anymore and there is not enough voltage for the power train transistors to turn-on.

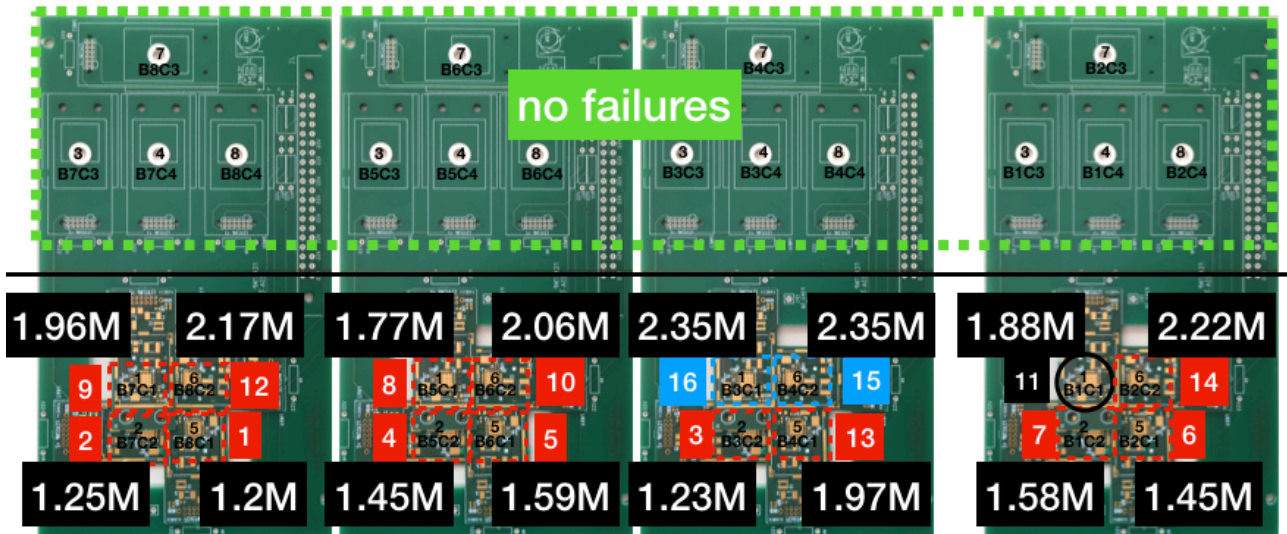
Figure 11: Detail of the modules damaged during the first irradiation run in IRRAD. All samples highlighted in red went to the High Current state at a dose whose best estimate is reported (in Mrad) in the black squares. The sample circled in black was the only one actually failing (Broken state), while those highlighted in blue went to High Current shortly after the end of the irradiation, while running at the same  $-25^{\circ}\text{C}$  temperature. None of the 16 samples above the mid-line of the boards and situated farther from the beam (smaller TID) had any observable damage. Note that these 16 samples are not shown, but are represented by the 16 numbered white holes on the top of the boards.

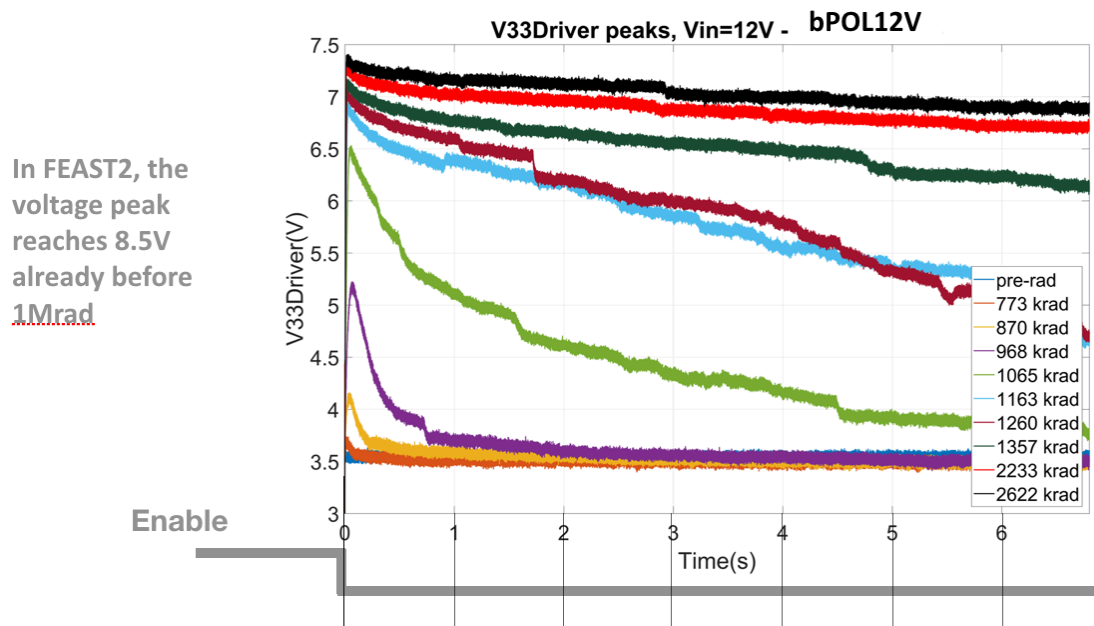
To understand the mechanism leading to the damage, we observed the voltage of the V33Dr node with the probe of an oscilloscope while the sample was exposed. Fig.12 shows the result for a bPOL12V sample where successive voltage curves taken at increasing levels of TID are superposed (results were even more spectacular for the FEAST2.1, where the voltage peak reached 8.5V already before a TID of 1Mrad). These curves all correspond to the time variation of the V33Dr voltage immediately after a disable command is sent to the module. As soon as the sample is disabled, the voltage rises and reaches a TID-dependent peak increasing with the dose. The duration of this pulse also increases with TID. This voltage clearly exceeds the 3.3V rating of the core transistors in the used technology, so it is not surprising that a device connected to the V33Dr node breaks (such as the clamp NMOS transistors).

Figure 12: Voltage on the V33Dr node observed with an oscilloscope as soon as the sample of bPOL12V is disabled at increasing levels of TID. Results were even more dramatic for FEAST2.1 samples (larger voltage peaks at lower TID levels). All these measurements were done with a large dose rate of about 4.5Mrad/hour.

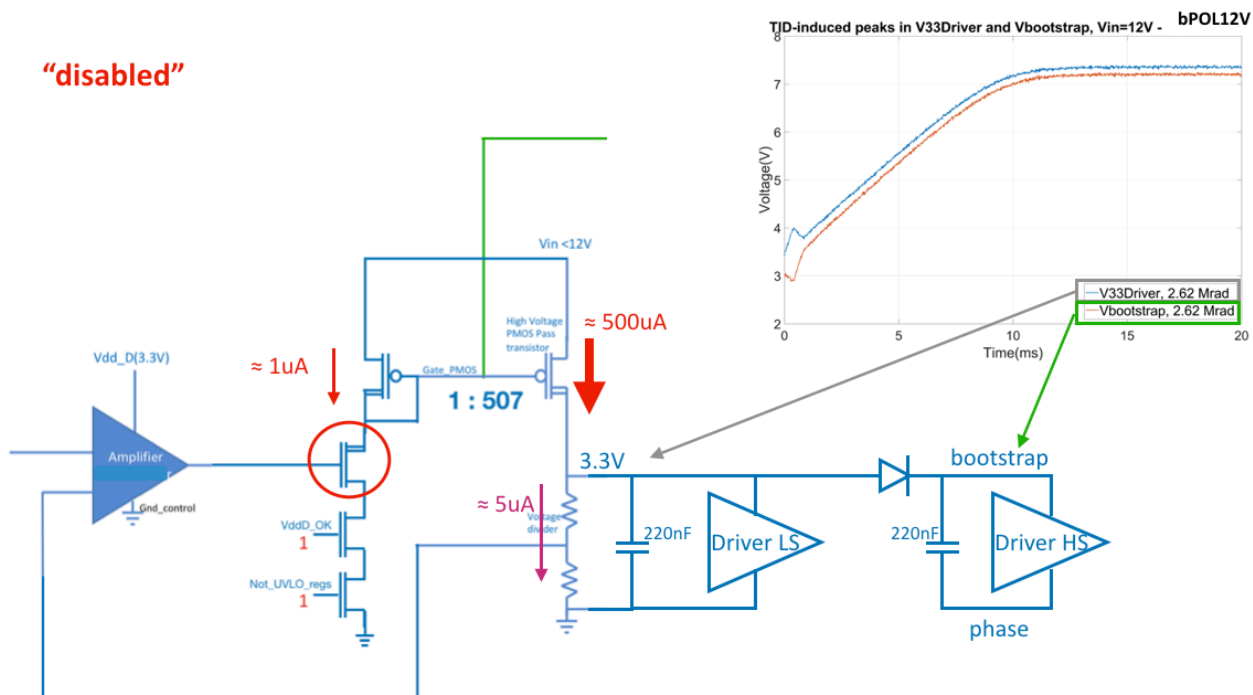
Figure 14: When the converter is disabled, the leakage current of the LNDMOS (hypothetically  $1\mu\text{A}$  here) is mirrored with a ratio 500 to the V33Dr node where it is integrated on the  $220\text{nF}$  capacitance. The voltage of the V33Dr node rises linearly until the bootstrap diode is forward biased, at which point the 2  $220\text{nF}$  capacitances are in parallel and the slope of the voltage rise is halved. The voltage rise is shown in the top right corner for both the V33Dr (blue) and Vbootstrap (red) nodes.

In the impossibility of cutting the leakage path, there are 2 provisions that can be implemented to prevent the damage: lowering the voltage peak and never turn the V33Dr regulator off. For the first, it is sufficient to lower the input voltage before disabling the converter (to 5V, for instance). The peak voltage at V33Dr can not reach the  $V_{in}$  at the disable time, because the pass PMOS transistor gets squeezed when its drain voltage approaches  $V_{in}$ .

The second provision can be implemented by the addition of an adequate resistance in parallel to the C33\_Dr capacitance. In our experiments at the X-ray machine a  $3\text{k}\Omega$  resistance was adequate even at the very large dose rate of  $4\text{Mrad}/\text{hour}$  and at room temperature. This requires a current of about  $1.1\text{mA}$ , and no peak was observed in this condition on the V33Dr node during exposure. We tried a  $15\text{k}\Omega$  resistor in the same conditions, and peaks were instead still observed.

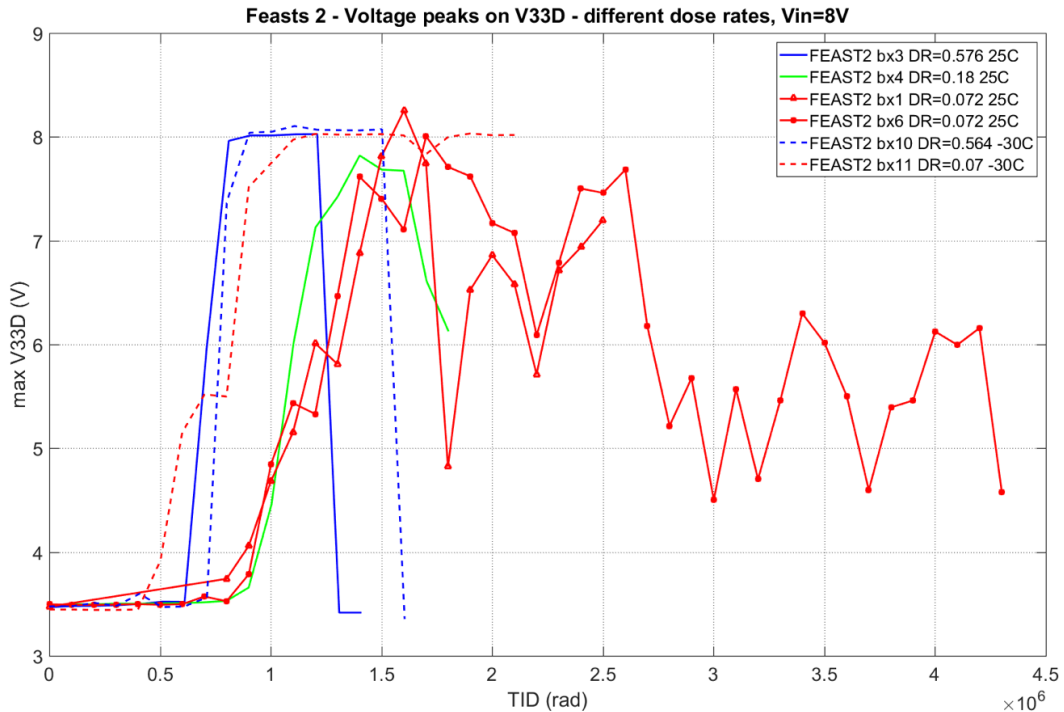
Samples exposed at  $-30^\circ\text{C}$  (dashed lines) show a sharp increase in the V33Dr voltage peak at doses between 500 and  $800\text{krad}$  at both of the two used dose rates (70 and  $500\text{krad}/\text{hour}$ ). The comparison of these results with the equivalent ones obtained at  $25^\circ\text{C}$  evidences that the lower temperature is a worst case condition, as expected from the normal behaviour of source-drain leakage current. When using the largest rate at  $25^\circ\text{C}$ , the voltage peak increase is comparable; however when the rate is decreased the threshold TID for the peak to appear shifts to larger

doses (about 1Mrad), the increase with TID is more gentle, and the samples are not damaged (the abrupt V33Dr voltage decrease in the blue lines happens when the High Current damage occurs). The figure also shows that, at lower dose rates, the voltage peak decreases gently when the TID is larger than 2-3Mrad. This is also in agreement with the observation that the source-drain leakage in single LNDMOS transistors reaches a peak around 1-2Mrad and then decreases with the accumulation of further dose.

Figure 15: Voltage peaks on V33Dr recorded on FEAST2.1 samples exposed in different conditions of temperature and dose rate. In the legend, the Dose Rate (DR) is indicated in Mrad/hour. Even the lowest rate in the test, 70krad/hour, still leads to the accumulation of 1Mrad in less than a day - so it should still be considered as a very high dose compared to those expected in the LHC experiments.

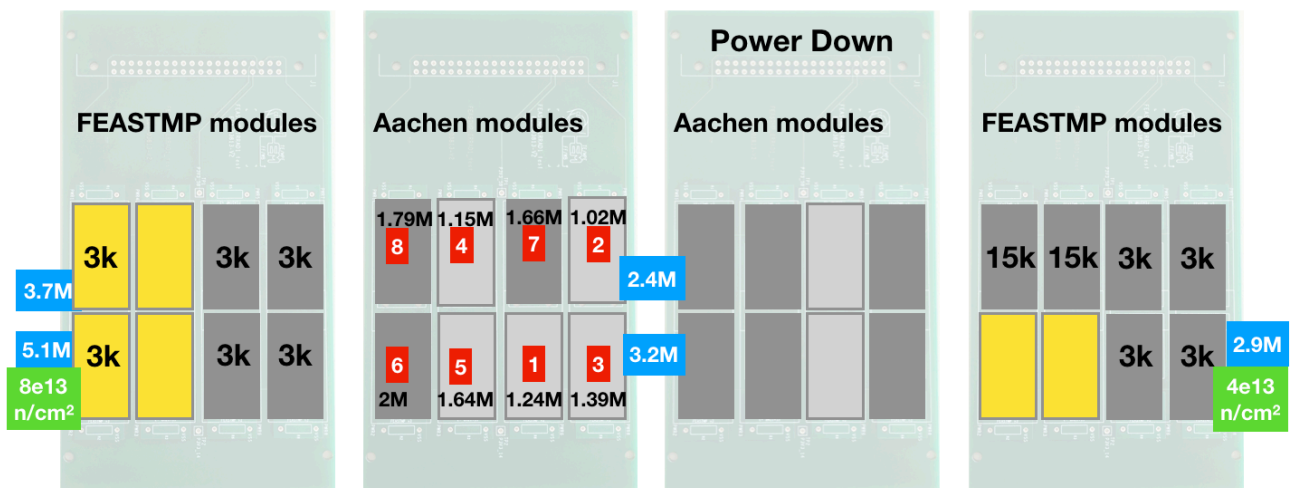
Only “high-current” damages were observed during the run, and exclusively on modules that were not protected by either an additional resistor (3 or 15kOhm) on the V33Dr or by the power-down sequence. Inside the cold box the damaged modules were all on the same board - but this was the only board containing unprotected FEAST2.1 samples. We can hence conclude that, as for the run1, if the TID is sufficient all the converters are eventually damaged. Fig.16 illustrates the 4 boards under test at  $-25^{\circ}\text{C}$  and highlights in red the damaged modules. The third board from the left, labelled “Power Down”, also had standard modules but here the supply was turned off to interrupt the modules’ output voltage (no disable was sent). In this way, the converters are disabled by the UVLO\_enable threshold which is below 5V - so this corresponds to the protection provision where the converters are disabled at lower voltage.

Figure 16: Summary of the results from the 32 modules exposed during the second IRRAD run at  $-25^{\circ}\text{C}$ , inside the cold box. FEAST2.1 samples are in grey, while bPOL12V samples are in yellow. Light grey modules were irradiated already in the first IRRAD run, but were undamaged during that run (they were in the farer section of the motherboards of Fig.11). Failing samples are marked in red, and the number is their chronological order of failure during the test. Close to each failure, the number in black reports the best estimate for the dose in Mrad at the time of failure. Samples protected by a resistor are distinguished by the text specifying the resistor value in Ohm (either 3 or 15kOhm). The third module from the left was protected by the a different provision: here the disable command was not sent but the supply to the module was turned off instead. Finally, in blue (TID in Rad) and green (fluence in 1MeV n-equivalent) boxes we report the best estimate of the radiation field from the available dosimeters in different locations.

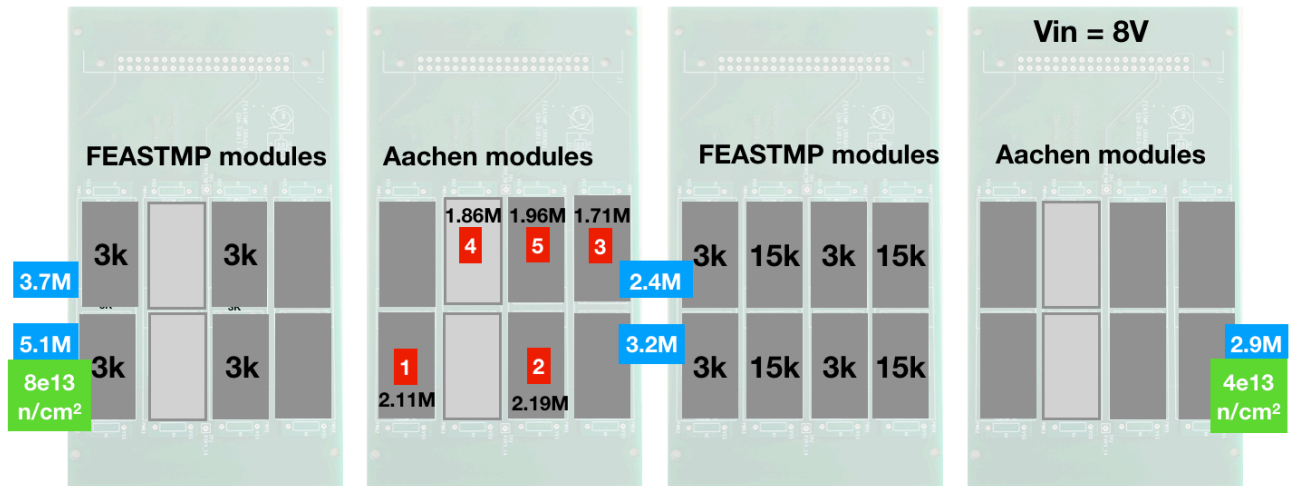
Outside the cold box, again only the unprotected modules powered at 12V were damaged, but not all of them. This is shown in Fig.17, where again the damaged samples are highlighted in red. Some samples in the first board to the right, as well as the not-highlighted modules in the second, were not protected but they were not damaged either - at least not at the dose reached during the test. None of the samples in the last board to the right, unprotected and using the same disable sequence as the others but powered at 8V (7.2V when the modules were enabled), was damaged.

Figure 17: Summary of the results from the 32 modules exposed during the second IRRAD run at room temperature (outside the cold box). All notations are the same as in Fig.16.

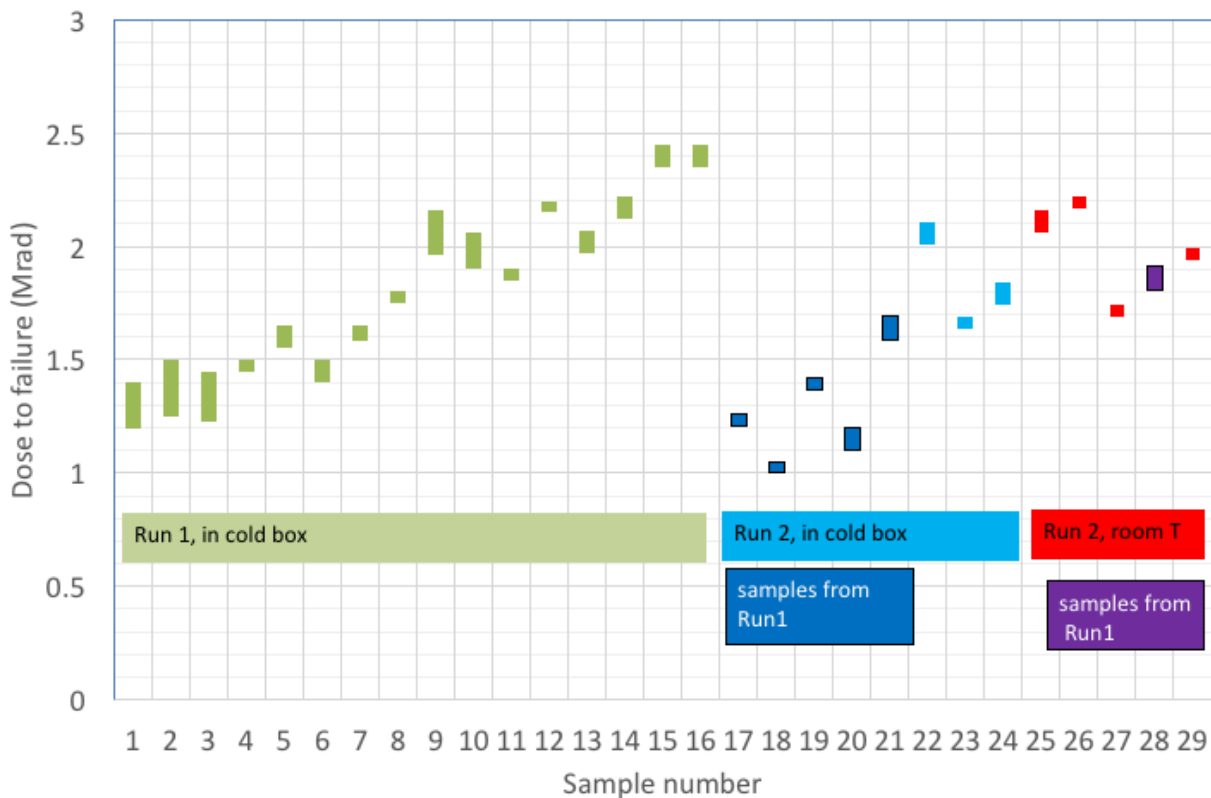
Estimated dose to failure in the two IRRAD runs

- damage only appears in all cases at estimated TID levels above 1Mrad
- samples at room temperature start to show damage at a dose larger than those kept at -25°C
- samples already exposed in run 1 are damaged at lower doses when irradiated again at -25°C, but this tendency is not observed at room temperature.

Figure 18: Estimated dose to failure for all samples damaged during the two IRRAD runs. Estimates are based on all the available dosimetry results, and the size of each data point only represents additional uncertainty proportional to the physical distance of the module to the nearest dosimeter. Green data points refer to the first irradiation run, blue (for modules in the cold box) and red (for modules at room temperature) refer to the second irradiation run. Samples exposed in both runs are represented with darker colours.

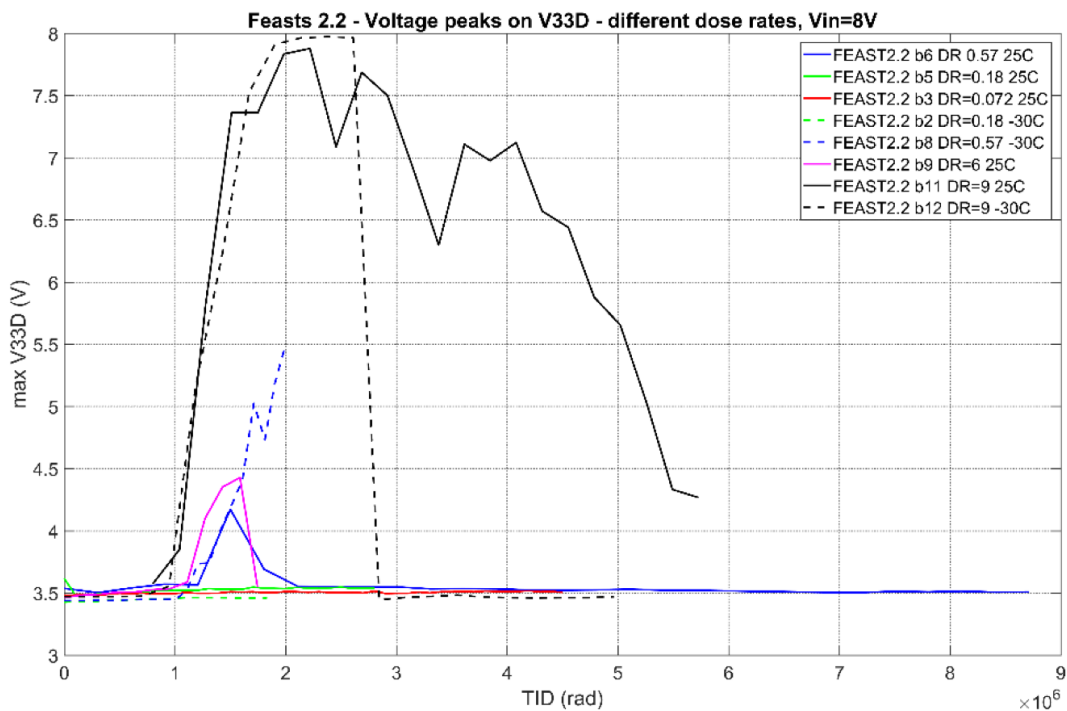
Figure 19: Voltage peaks measured with an oscilloscope on the V33Dr node of FEAST2.2 samples exposed to X-rays at different dose rate and temperature. The Dose Rate (DR) is expressed in Mrad/hour. At rates of 180krad/hour there is no evidence of voltage increase at both 25 and -30°C.

- the clamp transistors at the V33Dr node were removed, and replaced by a 15 kOhm resistor.
- a dedicated full ESD protection structure was added at the V33Dr pad.

X-ray irradiation confirmed also that the removal of the clamp transistors and the introduction of the resistor load on the V33Dr node is a very efficient way of protecting the chip. As for the FEAST2.1 chips in section 8 above, samples of the 2.2 version have been exposed to X-rays at different dose rate and temperature, setting an input voltage of 8V and observing the V33Dr voltage with an oscilloscope when the chips were disabled (every 100 krad, just after having stopped the irradiation). The evolution of the voltage peak is shown in Fig.19. Only at the highest dose rate of the X-ray machine, 9 Mrad/hour, the peaks reached the input voltage of 8V. When this irradiation was run at -30°C, the converter went in the High Current state. For the more reasonable dose rates of 500 to 70 krad/hour, and at both -30 and 25°C, the peak voltage is limited well below the input voltage. The available data still do not demonstrate with certainty that samples exposed at -30°C at particularly high dose rates (500 krad/hour or more) will not be damaged - although in this case the damage should always be the High Current state, since the clamp transistors have been removed. However, when looking at both the cold and room temperature data, it clearly appears that a voltage peak is only observable for samples exposed to a dose rate in excess of 180 krad/hour, a dose rate about 2 orders of magnitude superior to the one the converter modules are exposed to in the CMS pixel system.
