FEAST2.1 irradiation in the IRRAD facility

F.Faccio
CERN EP-ESE-ME

September 20, 2018

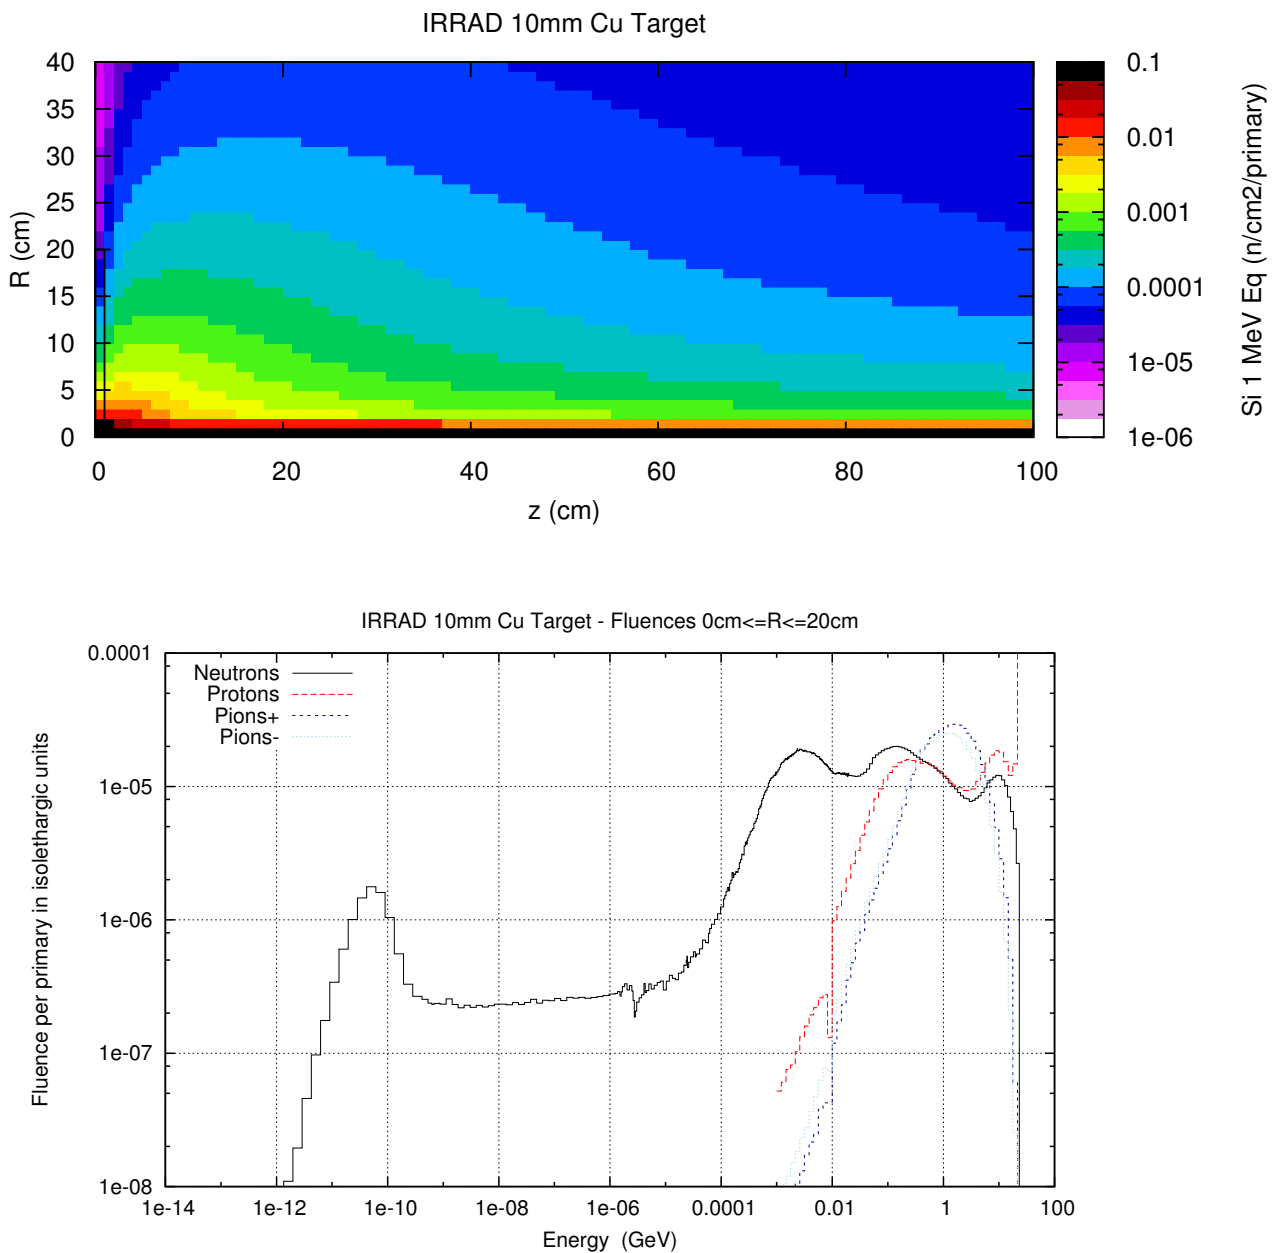
Figure 1: Simulation of the energy distribution and flux of the particles produced by the collision of the PS protons with the 1cm CU target introduced for this test.

The configuration of the IRRAD facility was modified on purpose for this test. Normally the experiments at this facility use the protons from the PS, and position the samples to be irradiated directly in the proton beam. This is not suitable for our purposes, since the rate of irradiation is excessive and protons arrive in very dense packets. To perform a representative irradiation, a 1cm thick copper foil was inserted on the beam to produce a shower of particles in the surrounding room. The following images illustrate, from simulation, the energy distribution of the resulting particles and their mapped flux in the surroundings of the beam.

With respect to the radiation map shown in Fig.1, the dimension of the motherboard is rather large and as a consequence the DCDC modules on each motherboard are exposed to a different flux of particle. This important characteristic was very useful to understand the results of the test.

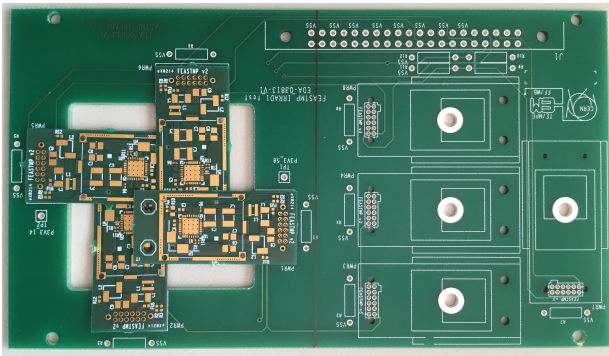
Figure 2: Layout of the motherboard for the first irradiation run, originally intended also for PSI.

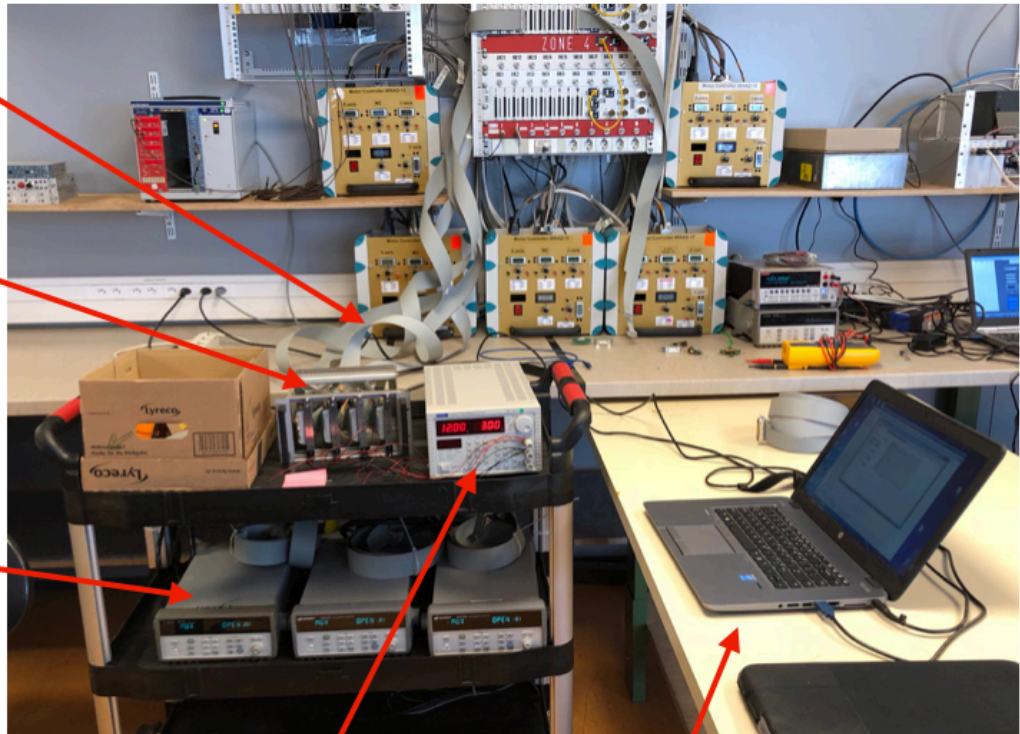
Flat cables (one per acquisition card) to DCDC motherboards

Crate with 4 breakout boards

Mainframe with acquisition cards (multiplexers and digital I/O)

Power supply

PC running tabview

Figure 3: All the instrumentation required for the test is positioned on a laboratory cart, here in the control room of IRRAD. The flat cables are the only connection to the motherboards in the beam, one flat cable per motherboard.

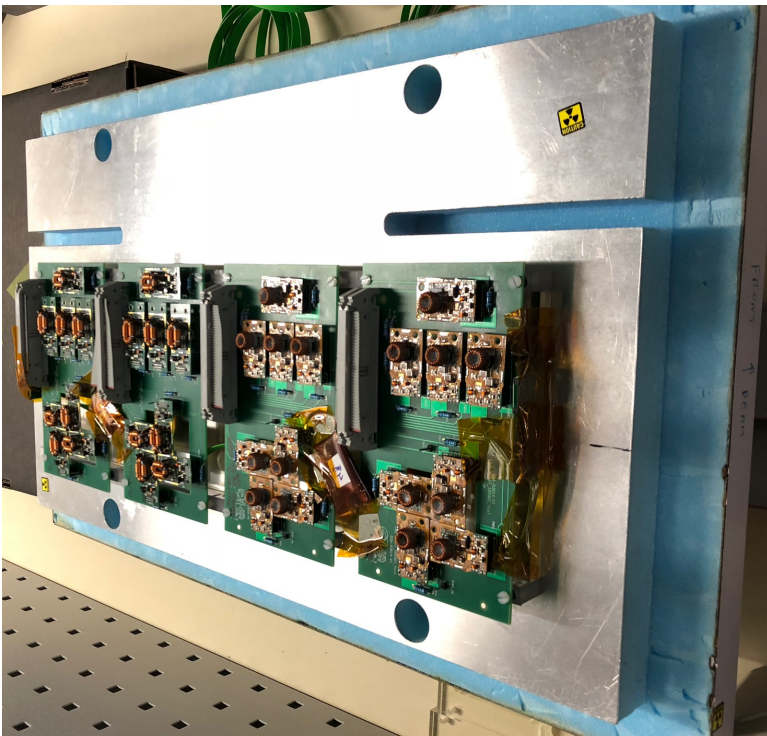
Figure 4: The 4 motherboards are installed on the cold box cover, ready for the exposure.

so 16 FEASTMP and 16 Aachen modules were part of the test - each family in fact made use of 2 dedicated motherboards (this can be seen in Fig.4, where the different module design is clearly observable). Also, samples included parts with different output voltage settings (1.5 and 2.5V) - also the V_{out} was found not to be discriminant in the CMS failures.

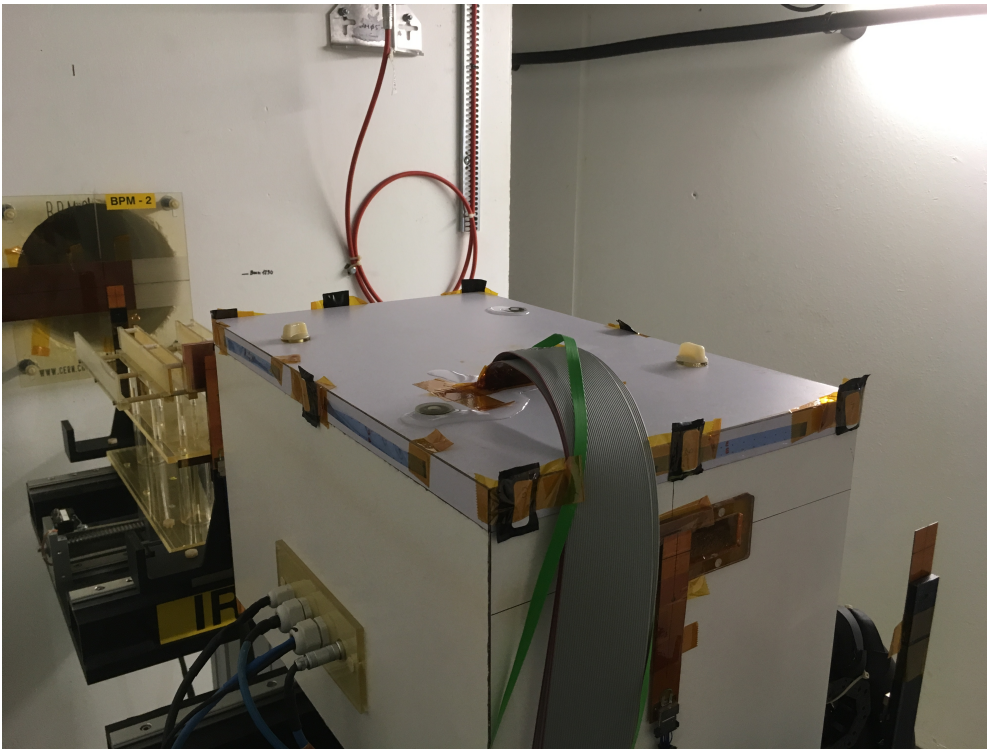
Figure 5: The closed cold box in its location inside the IRRAD experimental area. The Cu target is visible, as well as the 4 grey flat cables for the acquisition system and bias. The green cables are used for active dosimeters inside the box. Passive dosimeters were installed all around the box, on the cover.

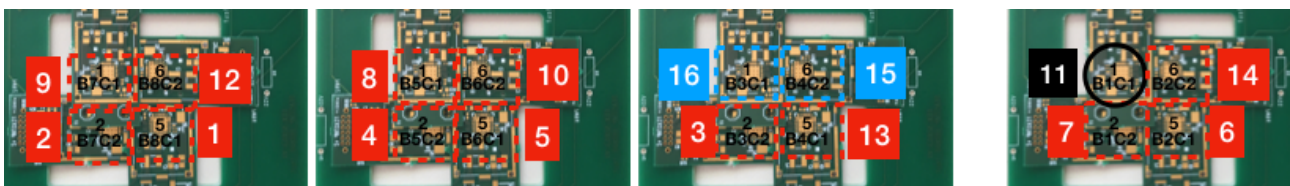
Figure 8: Table of the damaged converters in chronological order.

The table shown in Fig.8 reports the date and time of the damage, as well as the measured currents with the DCDC off or on immediately before and after the damage. All currents are at an input voltage (nominal) of 12V. Sign of damage (higher current) is systematically observed in proximity of a disable/enable cycle and most often as soon as the current is measured after a disable. This is similar to the failure of DCDCs in the CMS experiment - unfortunately we only have data for the failing converters in CMS, not for the vast majority of damaged samples that went into the "high current" state and for which we do not know when the damage occurred.

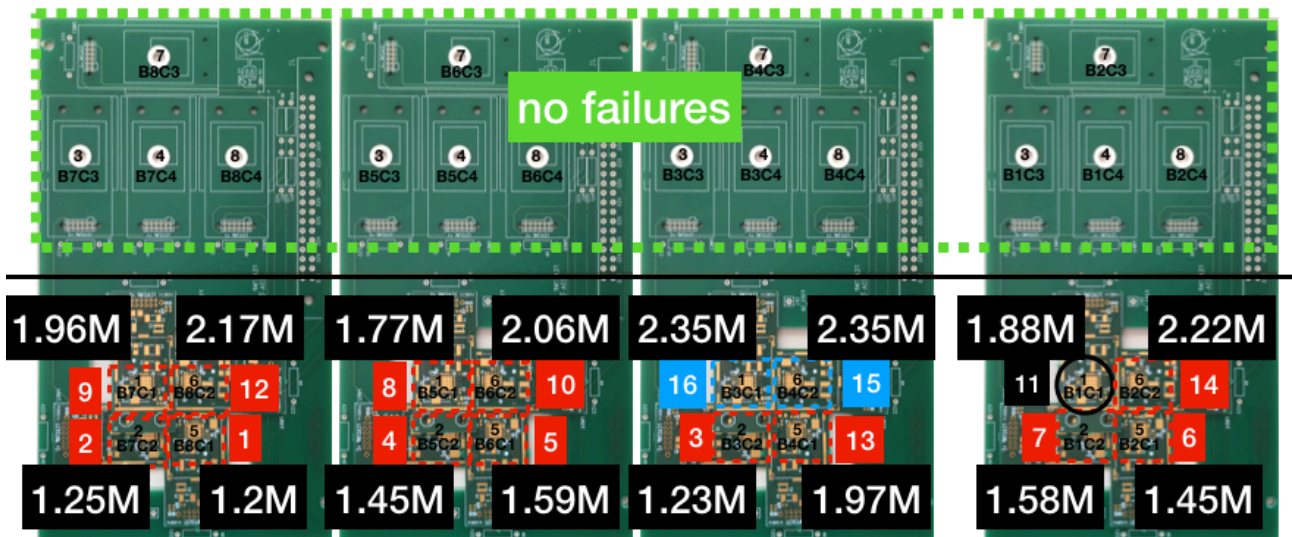
The estimate of the TID to failure for all samples is based on data from both this run and the second, where a better spatial covering of the volume was achieved by placing a larger number of passive dosimeters. The best estimates are reported in Fig.9. It is important here to highlight the limits of the dosimetry, not only due to the lack of adequate spatial coverage, but also to the type of dosimeter used. The passive dosimeters were of two technologies: alanine PADs and RPL. They were measured after irradiation, and the measured change in their properties compared with a calibration table where the same devices were exposed in a ⁶⁰Co source. Therefore the resulting TID levels indicate the equivalent dose of photons in air needed for the dosimeters to show a similar change in properties.

Figure 9: Best estimate of the TID to failure for all samples. The two samples in blue failed after the end of the irradiation, so their TID to failure is identical to the total TID at the end of the exposure. None of the 16 samples in the top green dashed area failed, however it is not possible to have a good idea of the dose these devices accumulated during the test - but certainly below 2Mrad. So the best conclusion one can get for the minimum TID to failure is the dose for the first failure, about 1.2Mrad, in the conditions of this experiment. Note that the 16 samples in the “no failures” zone are not shown, but are represented by the 16 numbered white holes on the top of the boards.

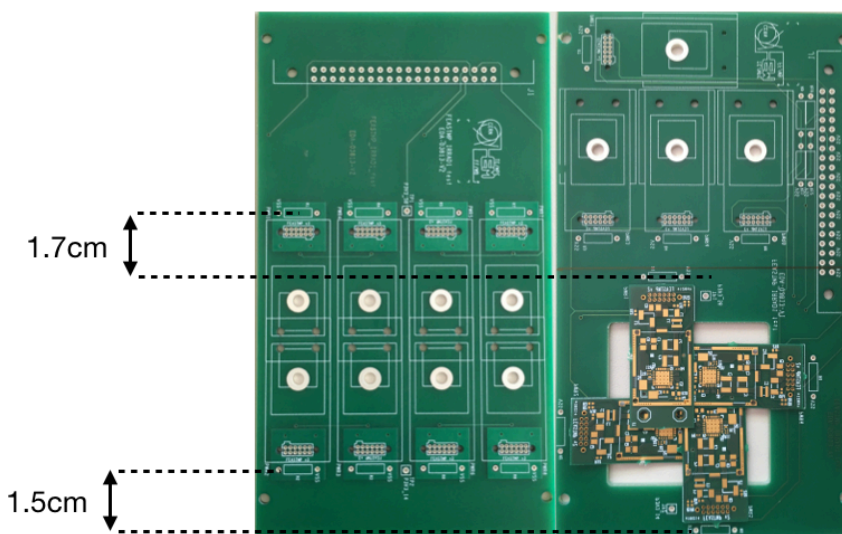
Figure 10: layout of the new (left) board compared to the old one used in the first run.

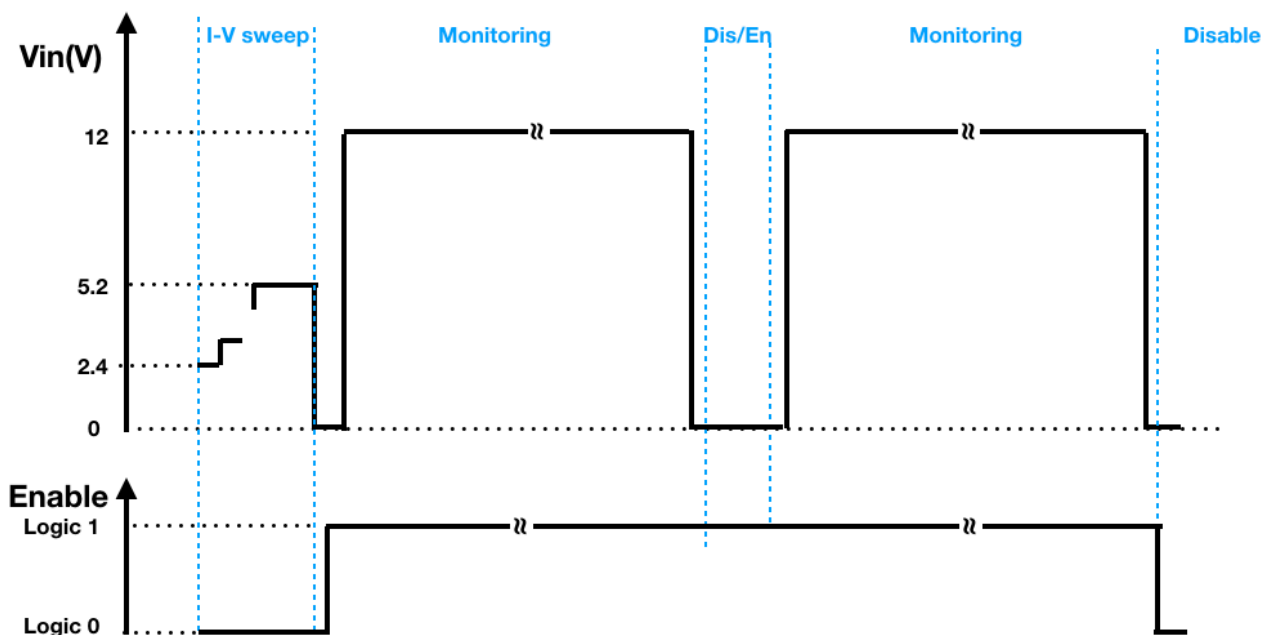
Figure 11: Graphical representation of the sequence used for a single motherboard in the cold box during the second run. The converter is only disabled for the I-V sweep, and remains enabled all the time otherwise. To turn it off, the supply voltage is interrupted.

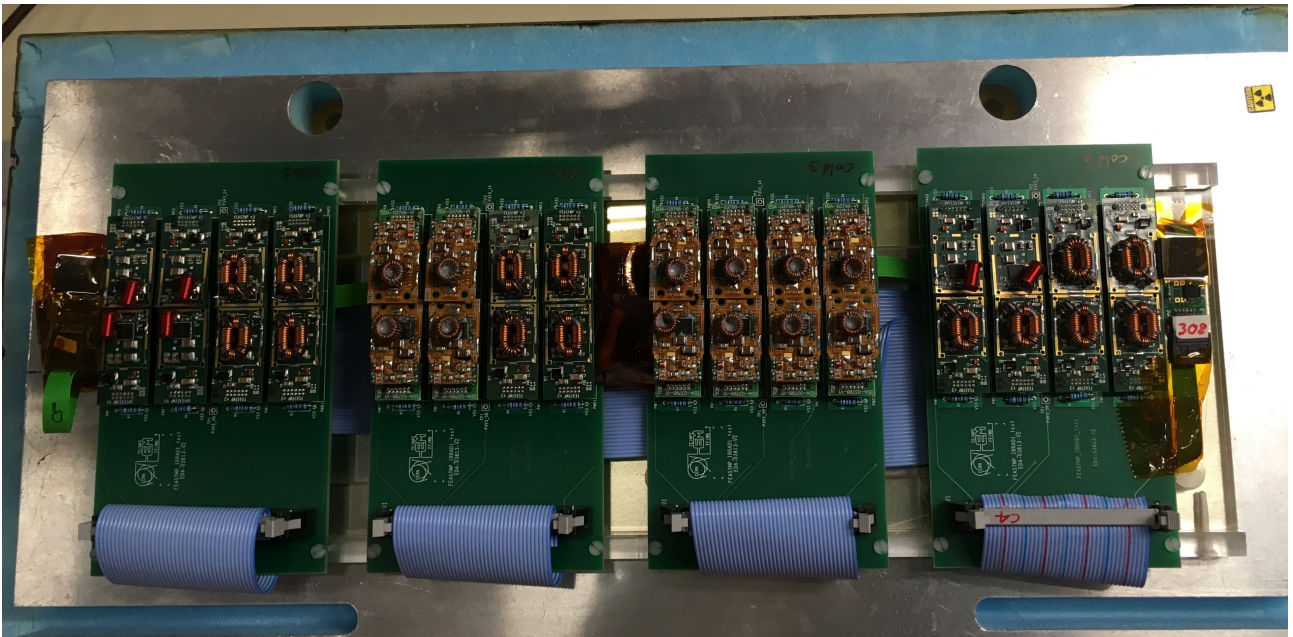
Figure 12: The 4 motherboards installed in the inner side of the box cover, ready for the installation in the experimental area. The dosimeters are visible. The third motherboard from the left was power cycled (sequence shown in Fig.10), while the others had the standard sequence used already in the first run. The actual position of the boards in the experiment is a vertical mirror of this image, where the inner side of the cover is visible.

In Figs. 12 and 13 we show an image of the motherboards installed on the top and bottom of the cover of the cold box, ready to be installed in the IRRAD beam line. In Fig.14, the cover is positioned on the box and all cables are connected to the pass-through system bringing the signals to the control room. In Figs. 12 and 13 it is possible to see the active and passive dosimeters that were enabling an improved spatial coverage with respect to run1. This should help knowing more precisely the doses to failure, and hence to determine a safe operating area for the modules using version 2.1 of FEASTMP. A detail of the position and type of the dosimeters is given in Fig. 15.

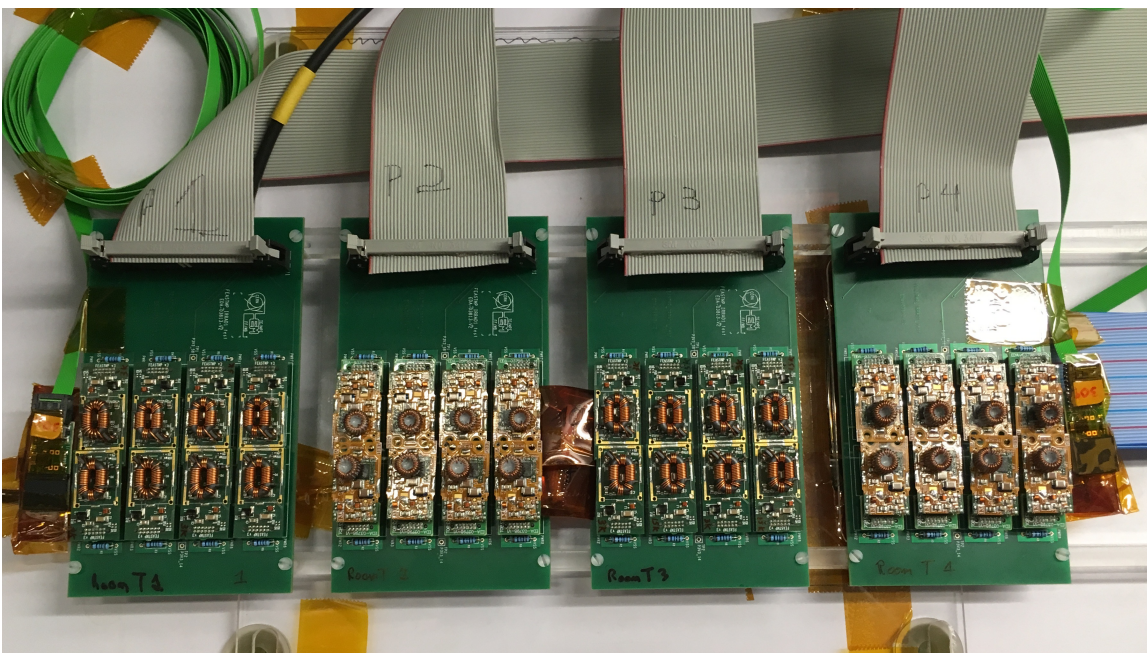
Figure 13: The 4 motherboards installed in the outer side of the box cover, ready for the installation in the experimental area. The dosimeters are visible. All boards had the standard sequence of I-V sweep and disable-enable, but the last board to the right was powered by a separate supply steadily at 8V (not controlled by the PC).

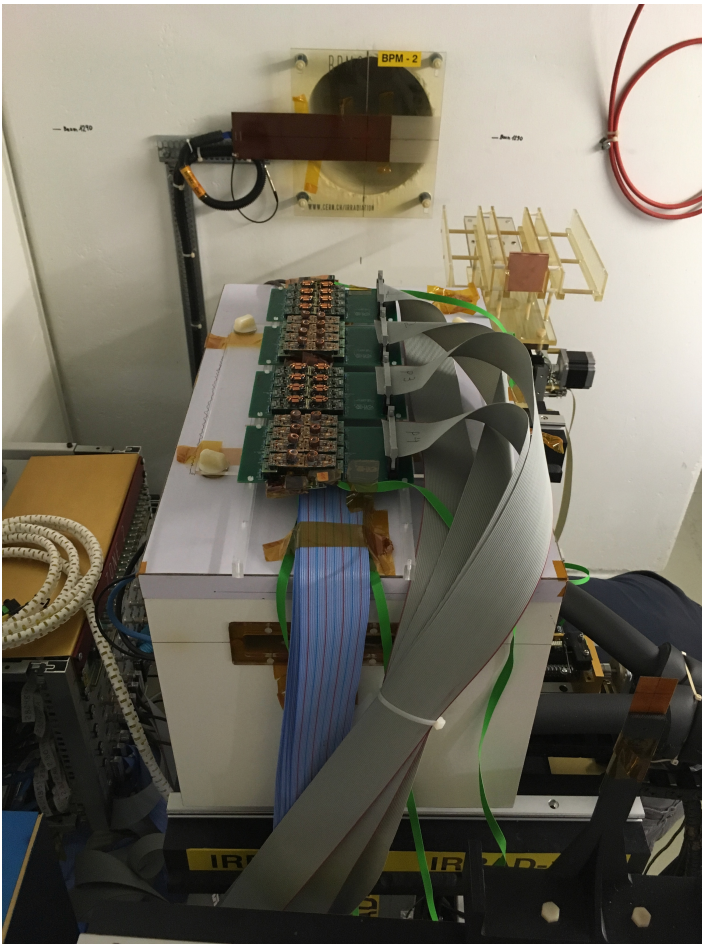
Figure 14: The full box ready for the irradiation run, with the 4 motherboards are room temperature on top.

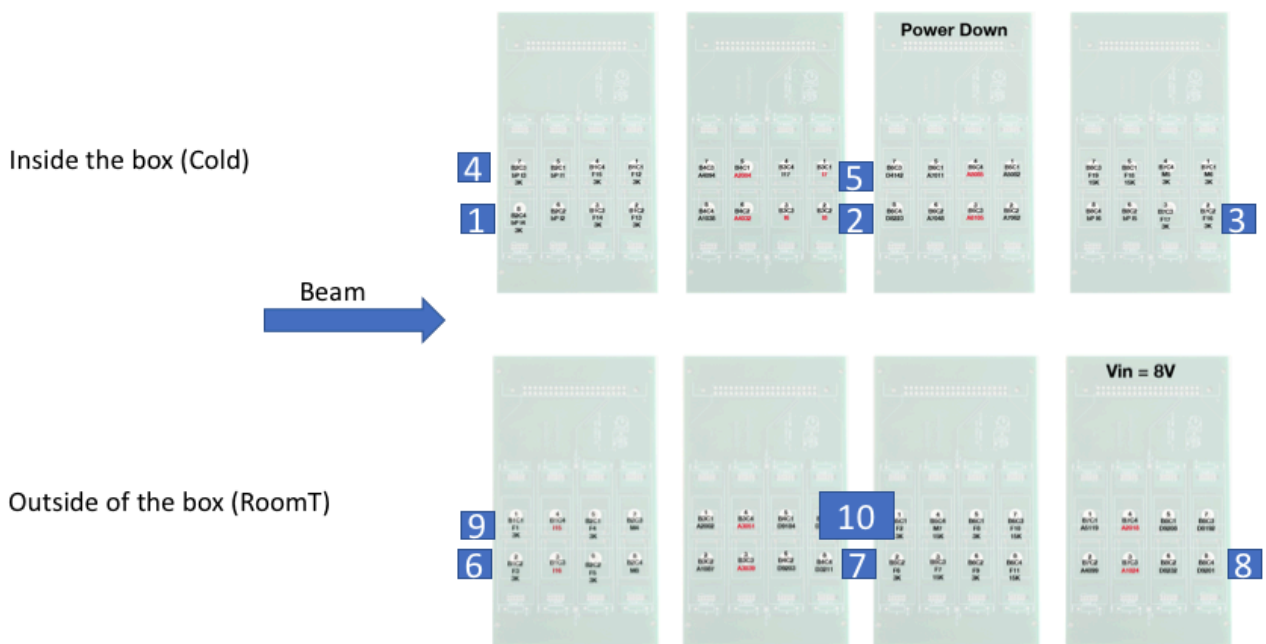
Figure 15: position of the passive dosimeters inside and outside the cold box. Active dosimeters were positioned in locations 6 and 8 (outside) as well as 1 and 3 (inside).

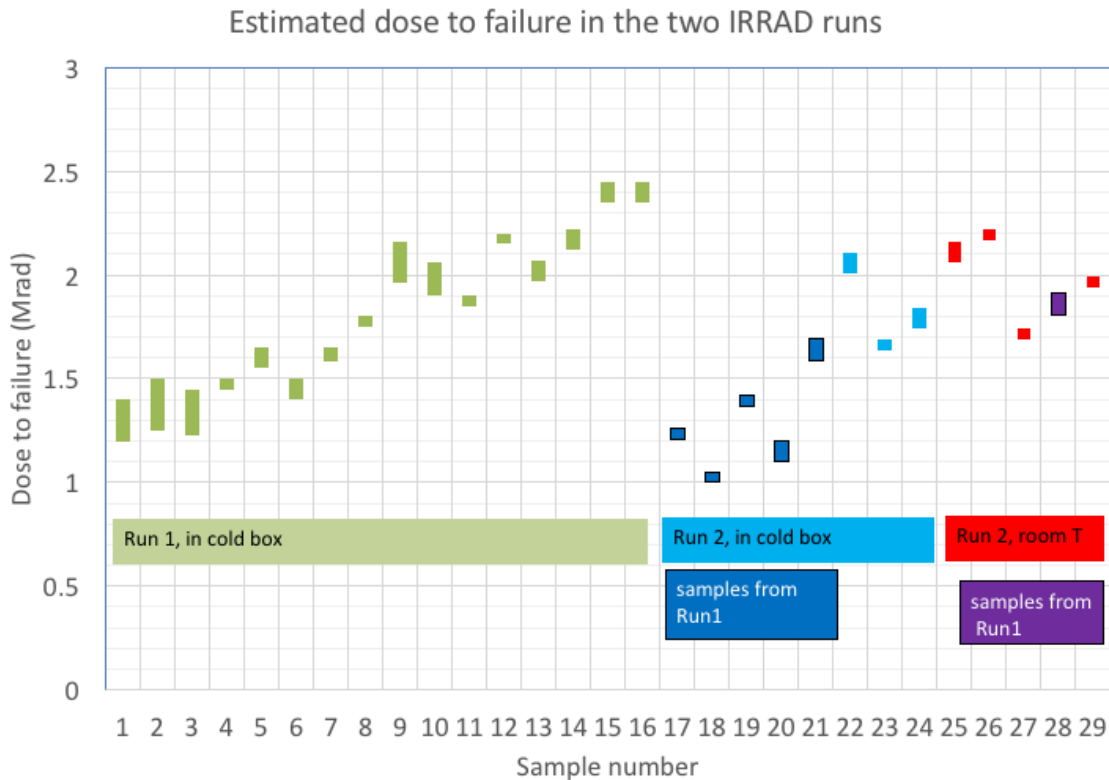
In order to define a safe area of operation for the FEAST2.1 converters, it is important to summarise all results obtained in the two irradiation runs. This is done in Fig. 19, that reports the best estimate for the TID to failure for all modules. The image has to be taken with caution, since the dose levels are, as already pointed out twice before, given by a combination of passive dosimeter results and extrapolation. Also, the size of each data point is proportional to the

uncertainty on the dose added by the physical distance of the device from a passive dosimeter - and only to that. The closer the module to a dosimeter, the smaller the uncertainty added by this parameter to the overall large error on the TID estimates. Some general conclusions can be drawn from these results:

- damage only appears in all cases at estimated TID levels above 1Mrad
- samples at room temperature start to show damage at a dose larger than those kept at -25C
- samples already exposed in run 1 are damaged at lower doses when irradiated again at -25C, but this tendency is not observed at room temperature.

Figure 19: Estimated dose to failure for all samples damaged during the two IRRAD runs. Estimates are based on all the available dosimetry results, and the size of each data point only represents additional uncertainty proportional to the physical distance of the module to the nearest dosimeter. Green data points refer to the first irradiation run, blue (for modules in the cold box) and red (for modules at room temperature) refer to the second irradiation run. Samples exposed in both runs are represented with darker colours.

These strategies were tested in both IRRAD run 2 and at the X-ray machine. The addition of a 3kOhm resistor very efficiently eliminates the leakage-current induced voltage peak, hence ensuring full protection at even the large dose rates of the X-ray machine. In the IRRAD run 2, samples protected with this strategy did not show any damage (some samples were irradiated to an estimated TID well above 3Mrad at -25C).

Both strategies seem hence efficient, but the preference should be given to the addition of a resistor because in this way the voltage peaks are completely removed and there is no impact on the system (powering down the full module, especially when several modules are powered by the same supply along long cables, is not very practical and might induce oscillations). On the other hand, although there is no evidence of damage when the supply voltage is reduced to 7-8V, an over-voltage is anyway present at the V33Dr node at every disable. This might lead to long-term stress on the module that in the long run might create reliability problems.

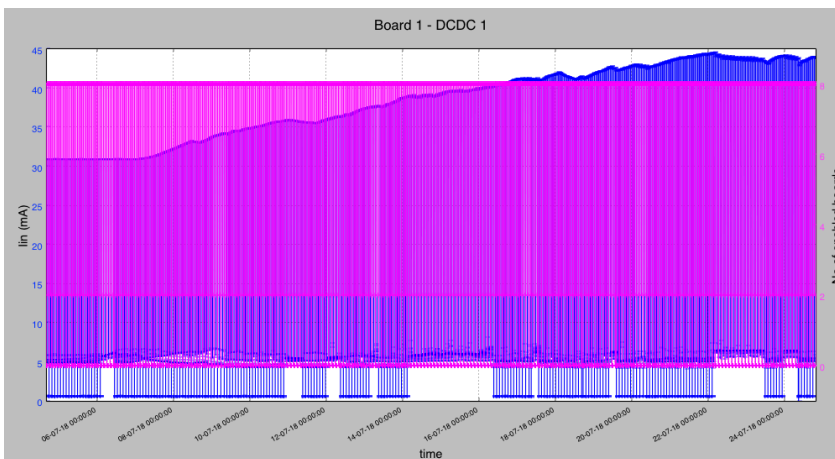
Since all input currents were monitored regularly during the irradiation, it is possible to analyse the available data and extract some additional information about the variation in the modules' performance in the radiation environment. This analysis was done thoroughly for both the modules in the cold box and outside of it. The input current measured during the full irradiation run for one cold sample (B1C1) is shown in Fig. 20 as an example. Only the blue line has to be looked at, the purple represents the number of converters enabled at any time. The figure is difficult to read, especially for the points taken during the I-V sweep, but it is possible to see the trend of increased on-current with time.

Figure 20: Input current (in blue) measured during each sequence for the full irradiation on converter module B1C1, inside the cold box. Only the on-current is readable in this graph, and it shows an increase in time associated to the TID-induced leakage current.

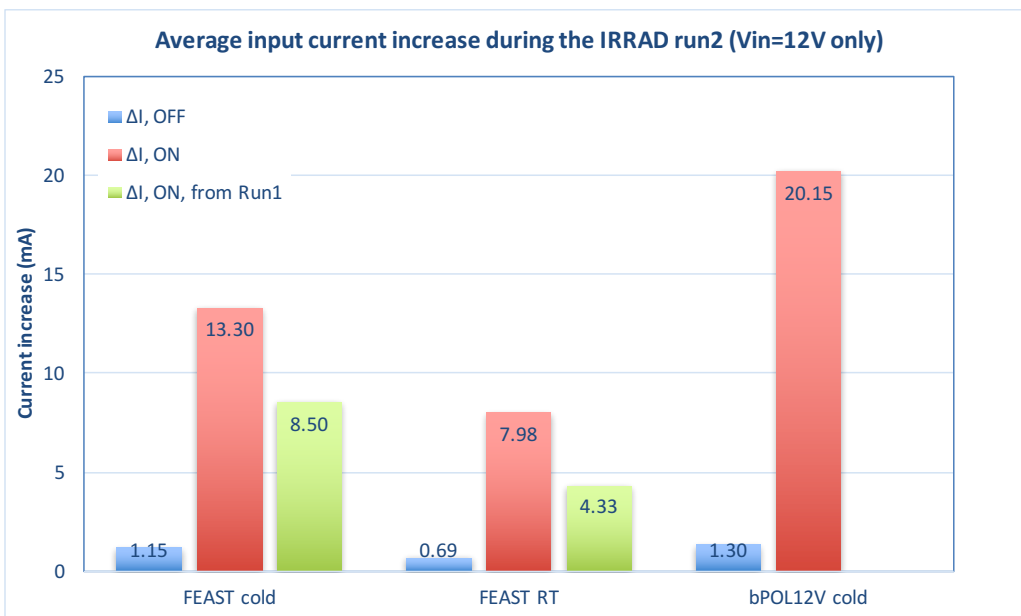
Other information can be extracted by the direct comparison of both off- and on-currents at the beginning and end of the irradiation for all converters. Given the relatively large variability in the converter characteristics (pre-irradiated in run1, fresh and unprotected, fresh and protected by a 3 or 15 kOhm resistors, FEASTMP vs. Aachen vs. bPOL12V, different output voltages, cold and room temperature), the observation of the trends enables some interesting conclusions. These are the main ones, some of which can be seen in Fig. 21 that summarises average results:

- Similar converters always show very comparable current increases

- Both on- and off-current increases are larger for cold modules than for modules at room T. This is in principle in agreement with the known temperature dependence of the TID-induced leakage current

- Similar converters positioned in different positions during the test yielded comparable results, indicating that the TID must have been rather uniform during the exposure. The only exception is for bPOL12V modules, indicating with low statistical significance that inside the box the dose was larger on the left board (see Fig. 17). The current increase was respectively 22 and 18mA

- FEASTMP and Aachen modules show very comparable results
- The output voltage is not affecting the on-current increase (with one possible exception for 3.3V at cold, but the statistical significance is low)

- Modules already exposed in run1 show a larger initial on-current by a few mA (not true for the off-current). Their current increase is then smaller during the run2

- Modules biased at 8V at room temperature seem generally to show a smaller increase
- bPOL12V samples have a significant larger current increase.

Figure 20: Average input current increase for FEAST2.1 (both FEASTMP and Aachen modules results are merged here) and bPOL12V samples. Results are for off- and on-currents of fresh modules, and compared with modules already exposed in run1, in green. The motherboards powered at 8V supply voltage are not included in the averages. Note that the modules from run1 have a smaller current increase during run2, but they already have a larger current than fresh modules at the beginning of run2.
