# Summary of measurements on FEAST2 modules to understand the failures observed in the CMS pixel system

F. Faccio, S. Michelis, G. Ripamonti  
CERN EP-ESE-ME

October 15, 2018

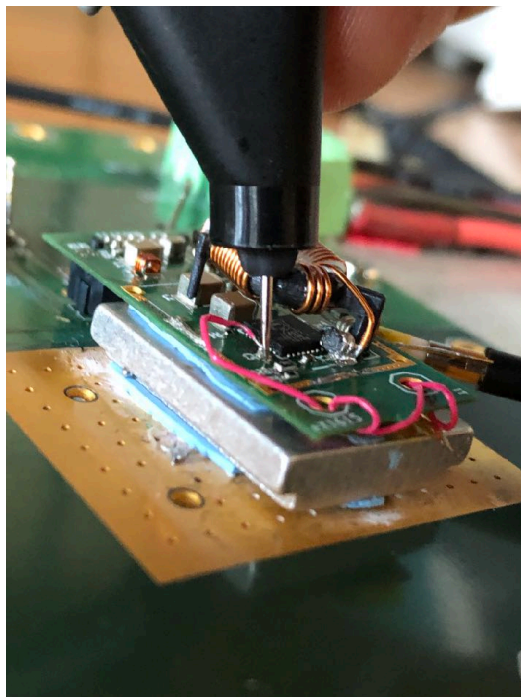
1. To produce the damage, it was necessary to avoid the contact of the tip of the ESD gun with the target: the discharge is faster and more severe if a spark develops and only in this condition a damage could be observed

2. The damage could be produced for discharges at the Rf, Enable and PowerGood pins. Probably all signal pins are sensitive, however we concentrated our tests on the Enable and PowerGood only, since these are connected to long lines in the application. Power pins were not sensitive, however

4. Modules installed on the standard test bench (as in Fig.3) required more discharges to be damaged with respect to modules installed on a small board like those used for irradiation, where the enable is a resistive bridge from Vin:

- a. When installed on the standard test bench, modules would be damaged in High Current mode after 2-20 single discharges. With more discharges some modules could fail in the broken state

- b. When modules were installed on the small irradiation board, damage was observed during the first few discharges, and the damage could be either the High Current or the Broken mode

*Figure 3: Tip of the ESD gun during injection tests on a FEASTMP module.*

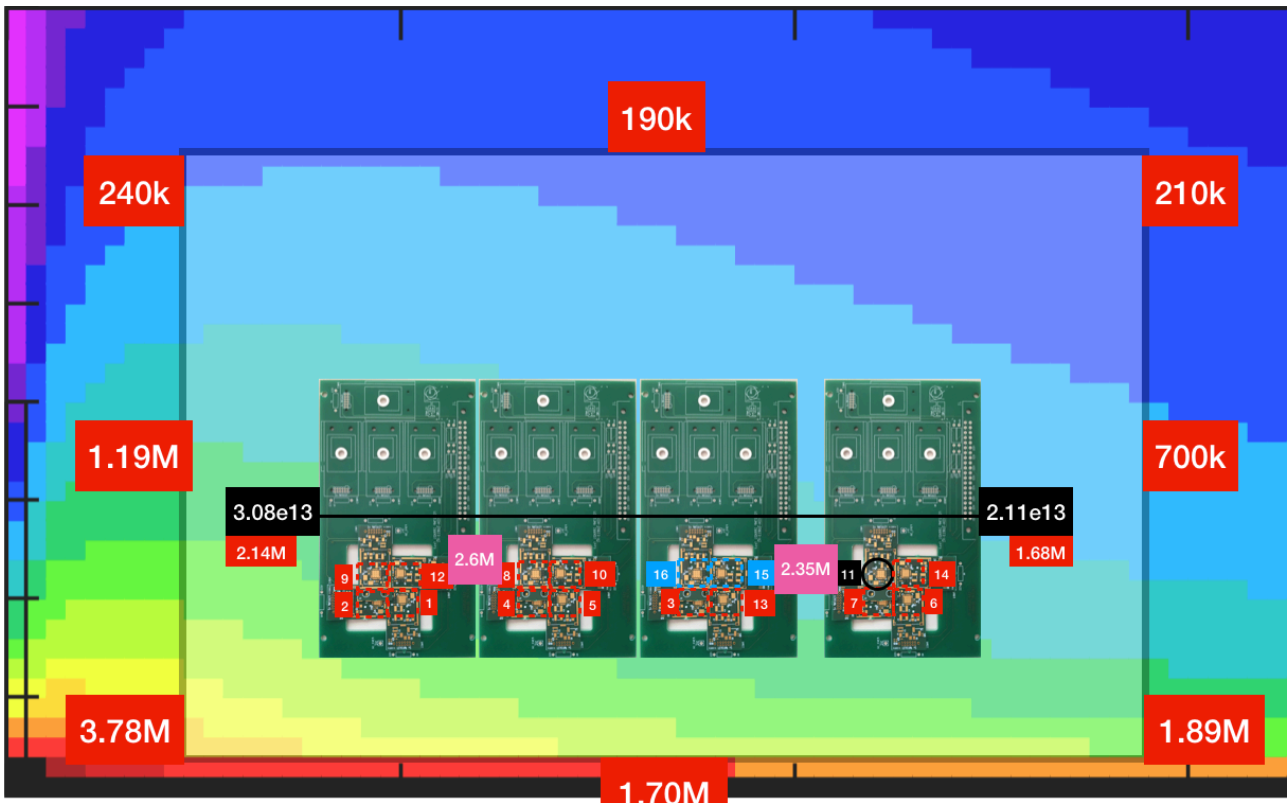
Due to the design of the test boards, that were developed in view of a further test on the proton beam line of PSI, and to the geometry of the radiation field, there was a large difference in the field intensity where the different samples were exposed. Fig.10 illustrates the position of the 4 motherboards, each containing 4 FEAST modules, in the cold box itself positioned in the simulated radiation field in IRRAD. Each motherboard contained 8 modules: 4 modules below the black line indicating the mid-point of the boards, and 4 considerably above it.

Figure 10: Position of the 4 motherboards with 8 modules each in the simulated radiation background created in the IRRAD facility by the insertion of a 1cm Cu target along the proton beam. Numbers in red/black/blue squares close to each module represent the chronological failure order. The other numbers in larger red/purple squares report the dose in rad registered by passive dosimeters in these positions, while in the black squares the 1MeV n-equivalent fluence from active dosimeters (diodes). All dosimeter readings refer to the integrated doses/fluences for the full exposure of about 20 days.

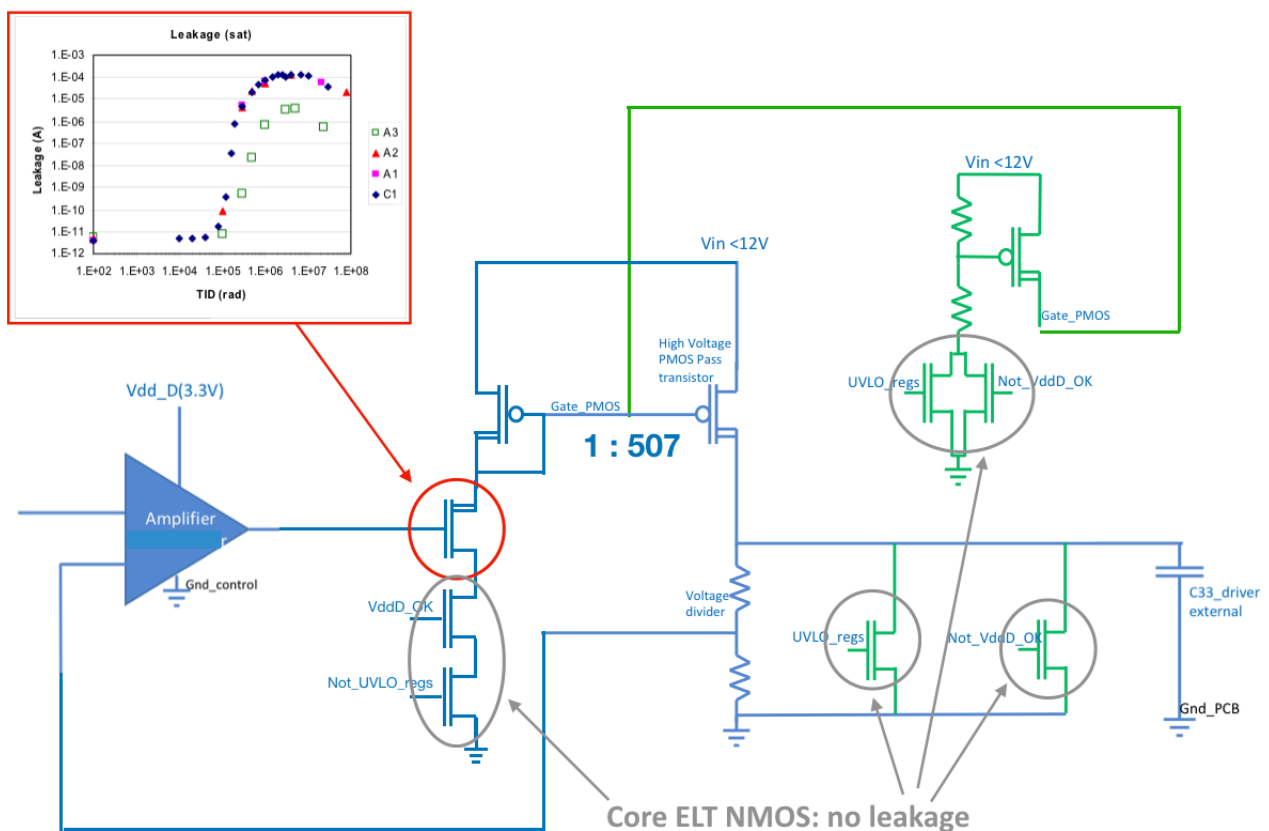
Very interestingly the TID level when this excess voltage appears on the V33Dr node coincides with the one where we know leakage currents reach their peak value in fast irradiations at room temperature. Looking for a “leaking” path in the circuit rapidly led to the discovery of the culprit: an LNDMOS transistor in the voltage shifter of the V33Dr regulator. This is shown in Fig.13. With respect to the representation in Fig.2, this schematic also shows the voltage shifter at the output of the amplifier in the feedback. Precisely in this shifter, the LNDMOS transistor circled in red is known to be sensitive to TID-induced leakage current. When the regulator is providing current to its output (to the buffers of the power transistors during operation) the LNDMOS is turned on and the leakage is adding up to the main current. This mainly alters the Vgs necessary for that transistor. However, when the converter is disabled the pass PMOS transistor should only provide the 5uA needed by the 2 resistors in the voltage divider (600kOhm overall). If the leakage in the LNDMOS is larger than some tens of nA, the mirrored current in the pas PMOS exceeds the 5uA and the current can only flow in the C33\_driver external capacitance, where it is integrated as a voltage. This is illustrated in Fig.14, where the waveform of the V33Dr (blue) and of the bootstrap (red) nodes during the rise of the voltage is shown. At first only the V33Dr capacitance gets the current, and the rising slope is larger. When the bootstrap diode can flow current, the 2 capacitors are in parallel and share the charge, then they both charge up. From the slope of the curve, we estimate a current of 2-300uA from the pass PMOS transistor. This is a reasonable value: it requires several 100nA leakage from the LNDMOS.

It should be noted that 2 core ELT transistors are in series to the leaking LNDMOS. This type of structure is used purposely to interrupt the possible leakage path of the LNDMOS, but in this case it is useless because the 2 transistors are closed above the UVLO thresholds - so they are turned on during disable.

Figure 13: A more complete schematic representation of the regulator for the power drivers (V33Dr) that includes the voltage shifter as output stage of the amplifier. The LNDMOS encircled in red is subject to radiation-induced leakage current (shown in the red squared image) that can not be prevented by layout: changing the layout to Enclosed Layout Transistor (ELT) is not compatible with the high voltage rating of the LNDMOS. The core NMOS are instead all ELTs and are not subject to leakage currents.
